**FEDERAL AVIATION ADMINISTRATION  
AIRWORTHINESS DIRECTIVES  
SMALL AIRCRAFT, ROTORCRAFT, GLIDERS,  
BALLOONS, & AIRSHIPS**

**BIWEEKLY 2004-17**

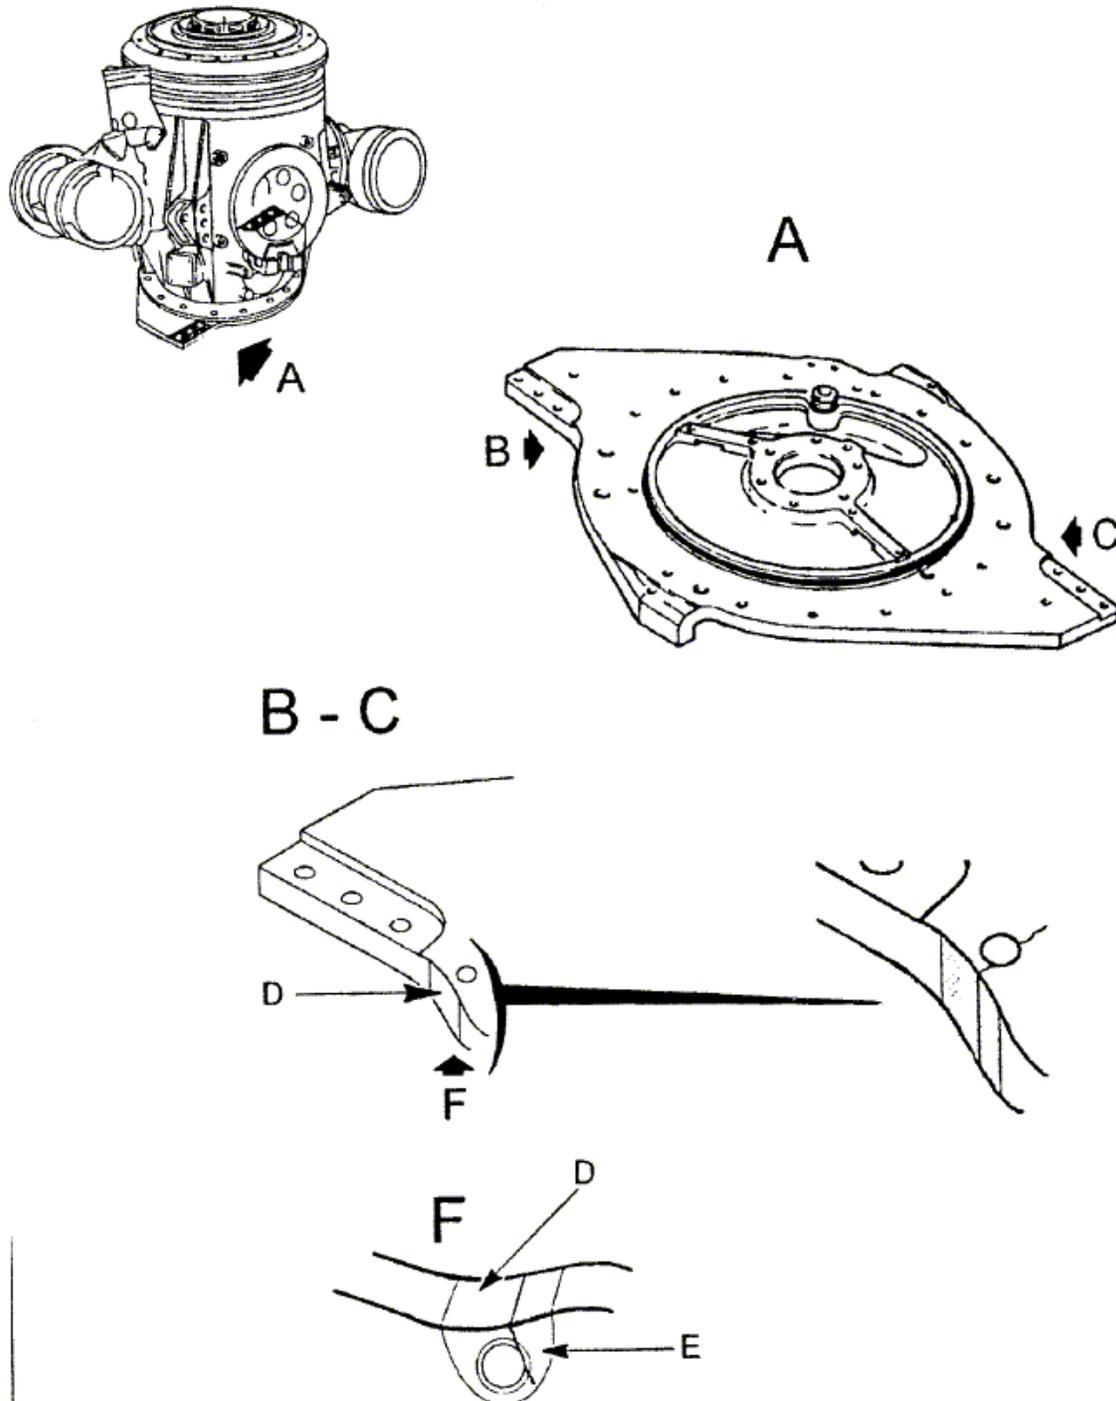
Figure 1

To detect a crack in the MGB base plate and prevent failure of a MGB attachment point to the frame, which could result in severe vibration and subsequent loss of control of the helicopter:

(a) Before the initial inspection at the time indicated in the compliance table, strip the paint from area "D" on both sides ("B" and "C") of the MGB base plate as depicted in Figure 1.

(b) At the times indicated in the compliance table, inspect area "D" of the MGB base plate for a crack using a 10x or higher magnifying glass.

(c) If a crack is found in a MGB base plate, remove and replace the MGB with an airworthy MGB before further flight.
