**FEDERAL AVIATION ADMINISTRATION
AIRWORTHINESS DIRECTIVES
SMALL AIRCRAFT, ROTORCRAFT, GLIDERS,
BALLOONS, & AIRSHIPS**

BIWEEKLY 2004-09

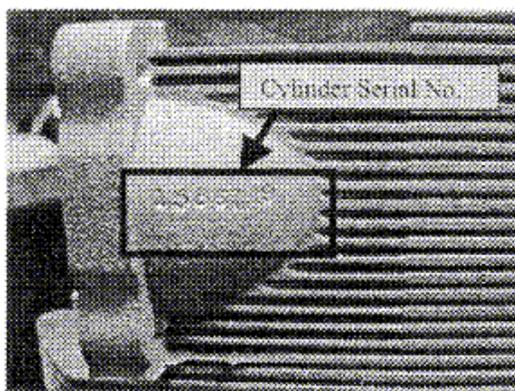
Figure 1.

(i) Determine the SN of the cylinder by looking in the engine records or by inspecting the cylinder for a SN on the intake port boss (see Figure 1) or on the flat area next to the head to barrel junction (see Figure 2). Disregard any dash numbers that might follow the four digit SN.

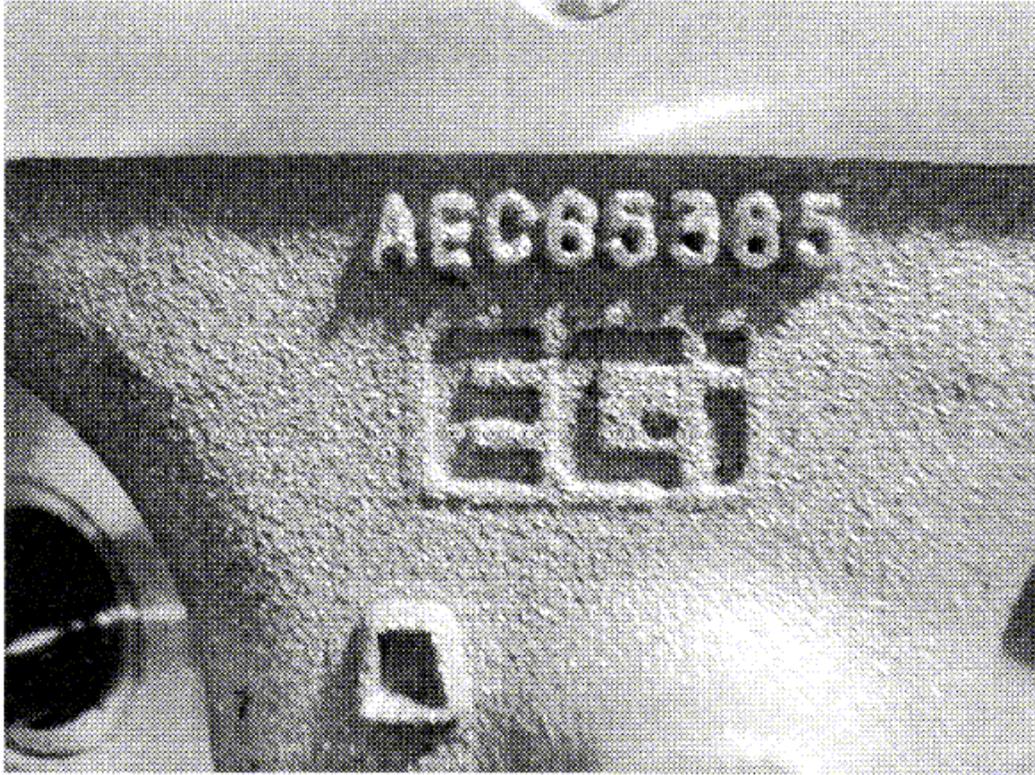
- (ii) If the SN is 1043 or lower, or if it is 7709 or higher, no further action is required.
- (2) If the cylinder SN is 1044 through 7708, do the following:
 - (i) Remove the rocker box cover from the cylinder.
 - (ii) Look at the left-front cylinder casting.
 - (iii) If the casting has AEC65385, and an "O" under the ECi logo, the cylinder is P/N AEC631397. See Figure 3.

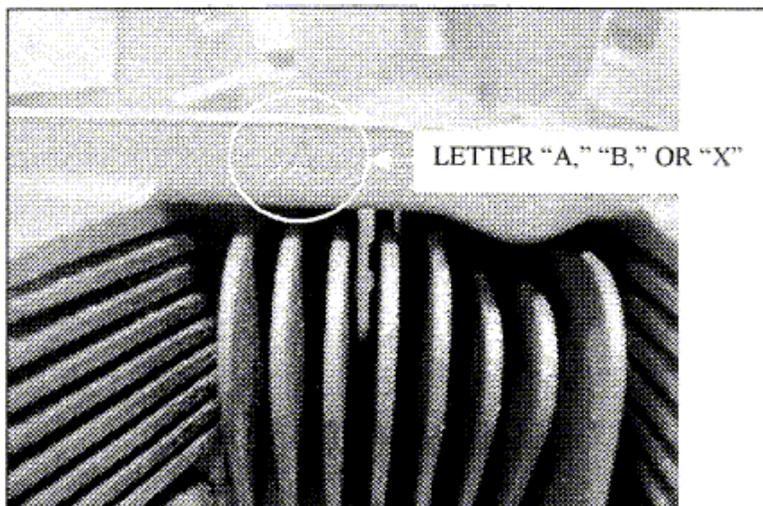
- (iv) If the cylinder is not ECI P/N AEC631397, no further action is required.
- (3) If the cylinder is ECI P/N AEC631397, do the following:
 - (i) Look at the flange of the rocker box.
 - (ii) If there is a letter "A," "B," or "X" stamped on the flange of the rocker box, no further action is required. See Figure 4.

- (iii) If there is no letter "A," "B," or "X" stamped on the flange of the rocker box, replace the cylinder before further flight.
