**FEDERAL AVIATION ADMINISTRATION
AIRWORTHINESS DIRECTIVES
SMALL AIRCRAFT, ROTORCRAFT, GLIDERS,
BALLOONS, & AIRSHIPS**

BIWEEKLY 2004-09

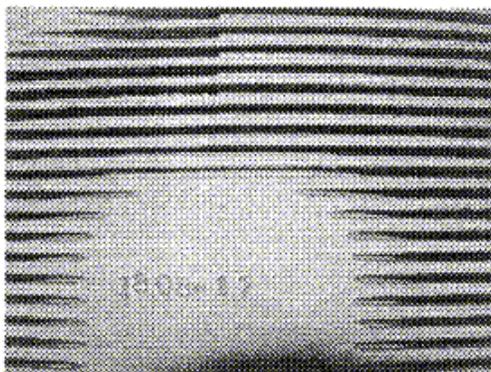
Figure 2.

(i) Determine the SN of the cylinder by looking in the engine records or by inspecting the cylinder for a SN on the intake port boss (see Figure 1) or on the flat area next to the head to barrel junction (see Figure 2). Disregard any dash numbers that might follow the four digit SN.
